Navajo Abandoned Uranium Mine Site Screen Report

Section 34 AUM Site

Navajo AUM Eastern Region

May 2009

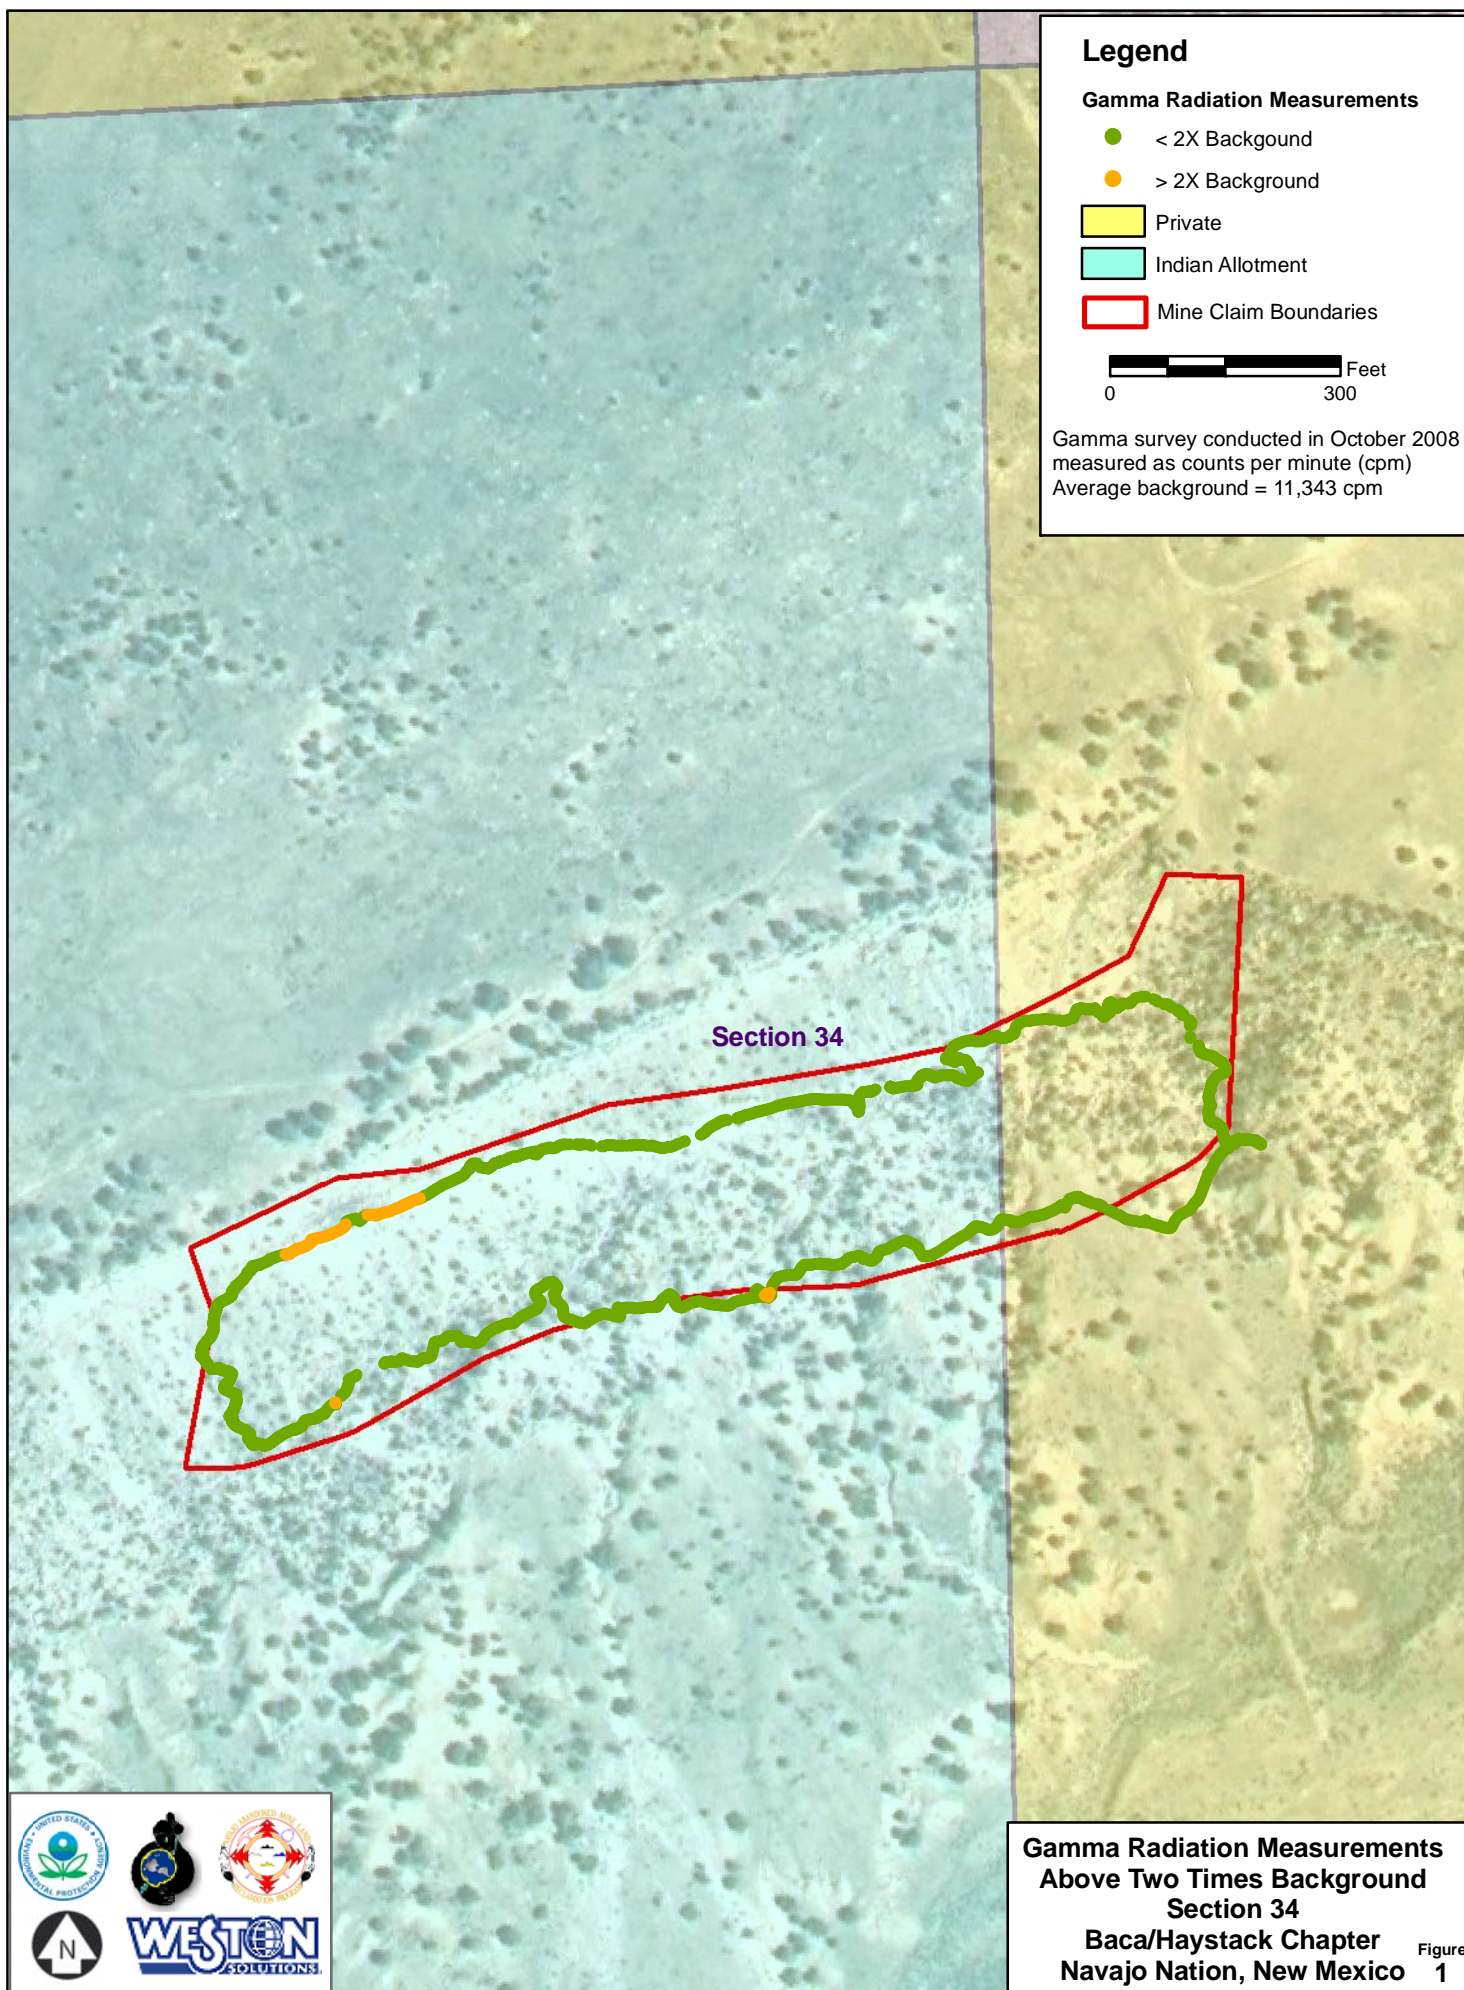
Figure
2

A total of 2,677 gamma radiation measurements were collected from mine sites, ranging from 6,544 cpm to 75,736 cpm. The measurements are represented in Figures 1 and 2.

Gamma survey conducted in October 2008
measured as counts per minute

Gamma Radiation Measurements
